# Manhole Inspection Summary

Manhole # S53Q\_\_011MH

Insp Date: **9/5/08 1:33 PM**

**Location** Address: **3201 boston st**

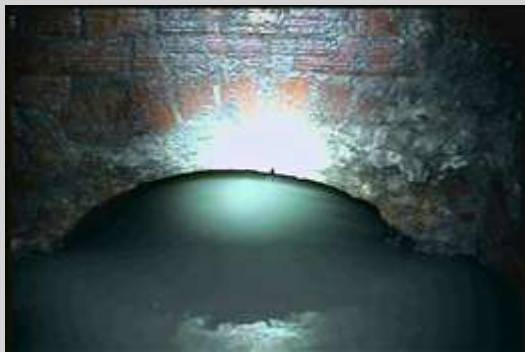
12 O'Clock Outflow

36 in. Circular Gravity Sewer  
Pipe Out @ 12 O'Clock

Pipe Material: **Concrete** ☐ Pipe Lined

Invert Depth: **27.96** (ft.) Flow Characteristics: **Fast**

Deposits: ☒ None ☐ Mud ☐ Sludge ☐ Debris ☐ Grease

Infiltration: **None** Pipe Seal Cond: **Unknown**

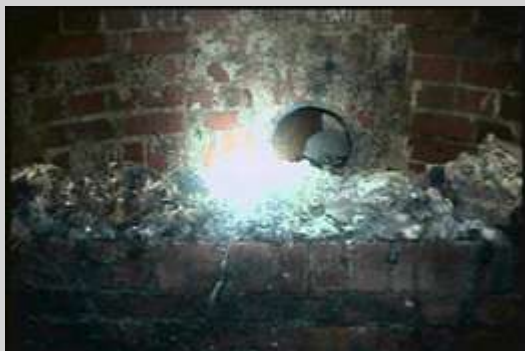
3 O'Clock Inflow

10 in. Circular Gravity Sewer  
Pipe In @ 3 O'Clock

under shelf couldnt get better pic

Pipe Material: **Clay** ☐ Pipe Lined

Invert Depth: **14.83** (ft.) Flow Characteristics: **Slow**

Infiltration: **None** Pipe Seal Cond: **Unknown**

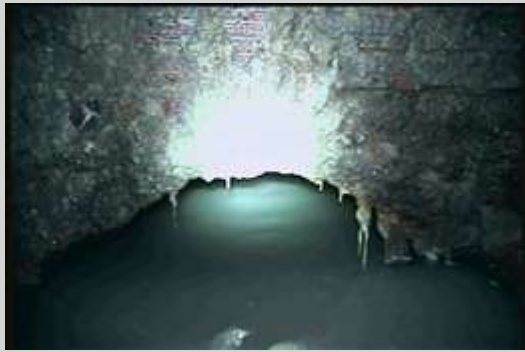
6 O'Clock Inflow

36 in. Circular Gravity Sewer

Pipe In @ 6 O'Clock

Pipe Material: **Concrete** ☐ Pipe Lined

Invert Depth: **27.92** (ft.) Flow Characteristics: **Fast**

Infiltration: **None** Pipe Seal Cond: **Unknown**

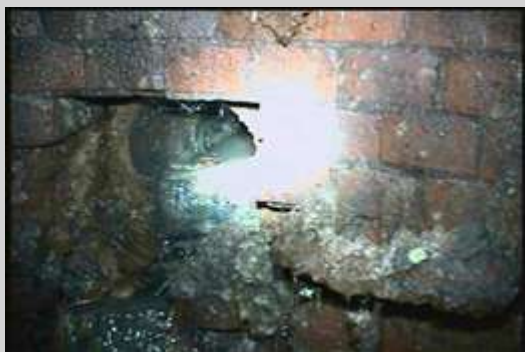
7 O'Clock Inflow

10 in. Circular Gravity Sewer

Pipe In @ 7 O'Clock

Pipe Material: **Clay** ☐ Pipe Lined

Infiltration: **None** Pipe Seal Cond: **Unknown**
